**Flood Control Project Maintenance
Levee Inspections**

Fall 2016 Levee Maintenance Deficiency Summary Report

Sacramento River Basin

Sacramento River West Side Levee District

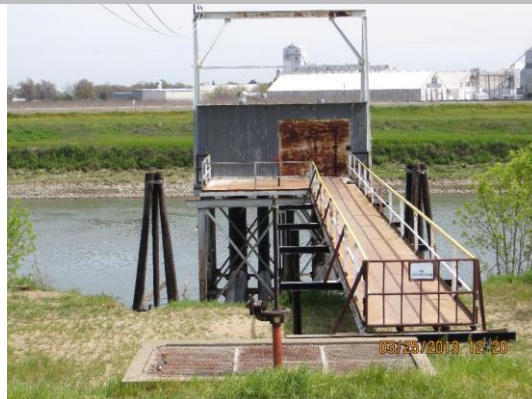
Photo 2 of 2 : UCIP_FA_2016_10103_17261.jpg

Comment Code					
Inspector Comment					
FS_ID:10103 DS_ID:20226 EP_NO: 1331 Repair Type: Non-Urgent Crossing Status: Found UCIP Comments: There is no gate in the slide gate at the concrete distribution box off the landside toe. This may not be an issue as there is a slide gate at the WS toe. FIELD_STRUCT_DESC: 54-inch corrugated metal irrigation pipe through levee 28.0 feet below crown. Vertical pumps on pile structure in the stream, walkway to pumps. Flap gates from pumps and slide gate inside a 7'X10-foot concrete surge box on the waterward side, 1948 installation. 15'X18-foot concrete distribution box 150-feet off landside toe with slide gate. (Permit No. 1331, 1948). Included in 1960 O&M manual. FS Date: 3/25/2013 7:36:51 AM

Pumping plant with concrete surge box and slide gate in foreground-off WS toe.

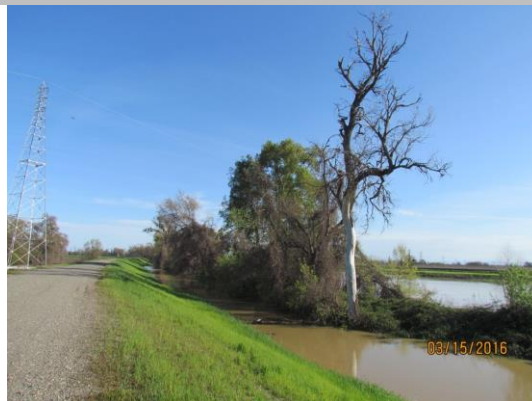
Photo 1 of 1 : FA_2016_NA0016_435_83_20160913_00034.jpg

LM Start	1.33	Rating **	A/W	Issue No.	83
LM End	1.33	Issue Type +	Ma	Location *	WS
Category	Earthen Levee			GPS Latitude/Longitude	
				Start	End
Item	Vegetation			38.817781°	38.817781°
				-121.725466°	-121.725466°
DWR ID	DWR_NA0016_01_s_2014_83				
Comment Code					
V7 : Trees / Woody Vegetation					
Inspector Comment					
Monitor trees that pose a future threat to the integrity of the levee

View of the tree on the waterward side of the levee looking upstream.
Spring 2016.

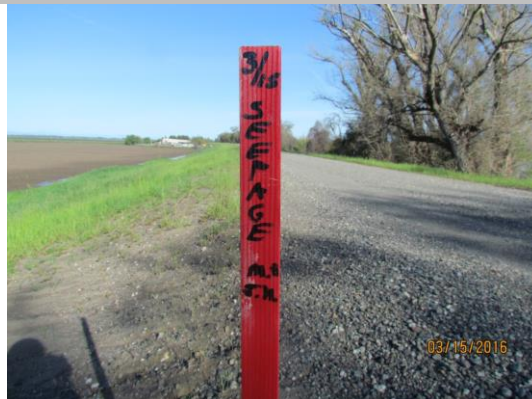
Photo 1 of 2 : FA_2016_NA0016_435_149_20160913_00073.jpg

LM Start	2.17	Rating **	U	Issue No.	149
LM End	2.38	Issue Type +	Ob	Location *	LS
Category	Earthen Levee			GPS Latitude/Longitude	
				Start	End
Item	Seepage / Sandboils			38.829567 °	38.832050 °
				-121.726814 °	-121.729140 °
DWR ID	DWR_NA0016_01_s_2016_149				
Comment Code					
Inspector Comment					
Seepage area has been staked and noted by LMA. Monitor seepage site.

The monitoring stake is on the shoulder of the levee on the landward side. Spring 2016.

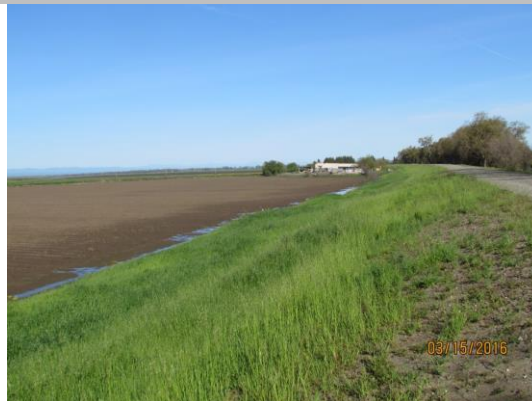
Photo 2 of 2 : FA_2016_NA0016_435_149_20160913_00074.jpg

View of the seepage on the landward side of the levee looking upstream. Spring 2016.

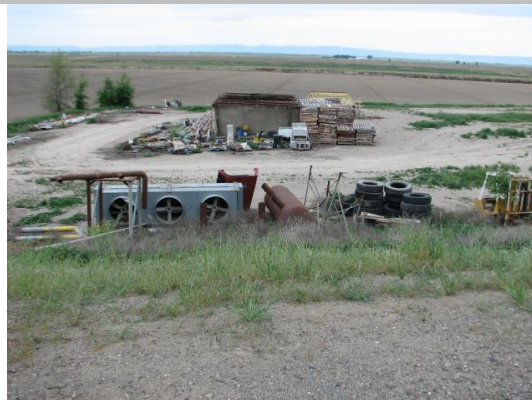
Photo 1 of 2 : FA_2016_NA0016_435_1550_20160913_00127.jpg

LM Start	2.39	Rating **	M	Issue No.	1550
LM End	2.39	Issue Type +	En	Location *	LS
Category	Earthen Levee			GPS Latitude/Longitude	
				Start	End
Item	Encroachments			38.832203 °	38.832203 °
				-121.729278 °	-121.729278 °
DWR ID	DWR_NA0016_01_f_2013_1550				
Comment Code					
EQ : Equipment					
Inspector Comment					
Equipment are at the levee toe.

Pieces of machinery and debris at the levee toe. Spring 2014

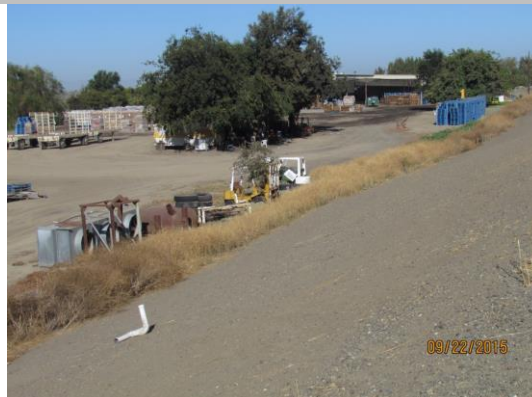
Photo 2 of 2 : FA_2016_NA0016_435_1550_20160913_00128.jpg

LM Start	2.39	Rating **	M	Issue No.	1550 (cont)	
LM End	2.39	Issue Type +	En	Location *	LS	
Category	Earthen Levee			GPS Latitude/Longitude		
				Start		End
Item	Encroachments			38.832203 °		38.832203 °
				-121.729278 °		-121.729278 °
DWR ID	DWR_NA0016_01_f_2013_1550					
Comment Code						
EQ : Equipment						
Inspector Comment						
Equipment are at the levee toe.

View of the machinery along the landward levee toe looking upstream. Fall 2015.

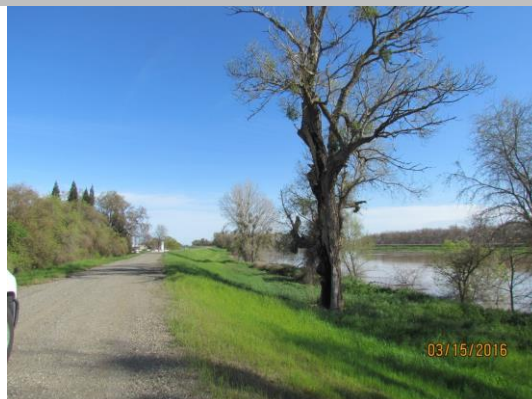
Photo 1 of 1 : FA_2016_NA0016_435_150_20160913_00075.jpg

LM Start	2.70	Rating **	A/W	Issue No.	150
LM End	2.70	Issue Type +	Ma	Location *	WS
Category	Earthen Levee			GPS Latitude/Longitude	
				Start	End
Item	Vegetation			38.835831 °	38.835831 °
				-121.732077 °	-121.732077 °
DWR ID	DWR_NA0016_01_s_2016_150				
Comment Code					
V7 : Trees / Woody Vegetation					
Inspector Comment					
Monitor trees that pose a future threat to the integrity of the levee.

View of the tree on the waterward side of the levee looking upstream. Spring 2016.

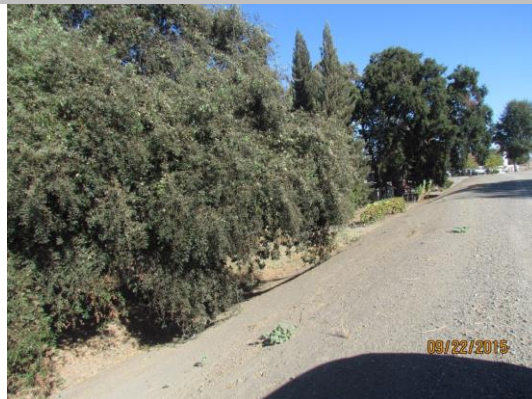
Photo 1 of 1 : FA_2016_NA0016_435_98_20160913_00041.jpg

LM Start	2.74	Rating **	M	Issue No.	98
LM End	2.74	Issue Type +	Ma	Location *	LS
Category	Earthen Levee			GPS Latitude/Longitude	
				Start	End
Item	Trim / Thin Trees			38.836454 °	38.836454 °
				-121.732037 °	-121.732037 °
DWR ID	DWR_NA0016_01_f_2015_98				
Comment Code					
T1 : Trim trees to at least five feet above ground level.					
Inspector Comment

View of the trees on the landward side of the levee that needs to be trimmed looking upstream. Fall 2015.

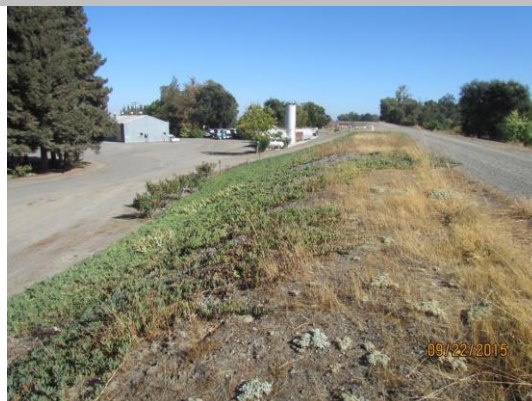
Photo 1 of 1 : FA_2016_NA0016_435_6_20160913_00006.jpg

LM Start	2.80	Rating **	M	Issue No.	6
LM End	2.80	Issue Type +	En	Location *	LS
Category	Earthen Levee			GPS Latitude/Longitude	
				Start	End
Item	Vegetation			38.837300 °	38.837300 °
				-121.731775 °	-121.731775 °
DWR ID	DWR_NA0016_01_f_2012_6				
Comment Code					
V6 : Landscaping					
Inspector Comment					
River Garden Farms

View of the landscaping along the landward slope at River Gardens Farms looking upstream. Fall 2015.

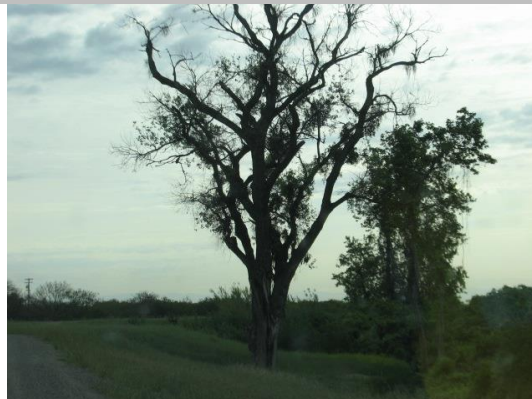
Photo 1 of 1 : FA_2016_NA0016_435_86_20160913_00037.jpg

LM Start	3.14	Rating **	A/W	Issue No.	86
LM End	3.14	Issue Type +	Ma	Location *	WS
Category	Earthen Levee			GPS Latitude/Longitude	
				Start	End
Item	Vegetation			38.841283 °	38.841283 °
				-121.728827 °	-121.728827 °
DWR ID	DWR_NA0016_01_s_2014_86				
Comment Code					
V7 : Trees / Woody Vegetation					
Inspector Comment

Monitor trees that pose a future threat to the integrity of the levee.
Spring 2014

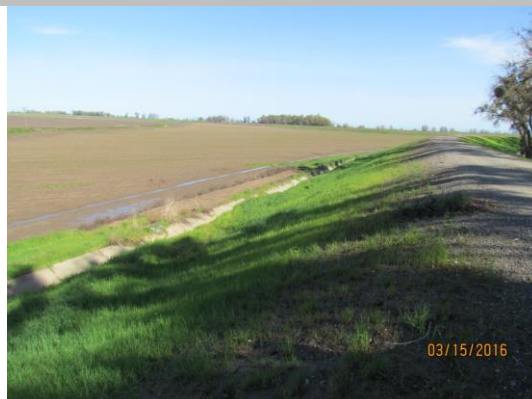
Photo 1 of 1 : FA_2016_NA0016_435_8_20160913_00008.jpg

LM Start	3.56	Rating **	M	Issue No.	8
LM End	3.94	Issue Type +	En	Location *	LS
Category	Earthen Levee			GPS Latitude/Longitude	
				Start	End
Item	Encroachments			38.846785 °	38.850758 °
				-121.729995 °	-121.725263 °
DWR ID	DWR_NA0016_01_s_2012_8				
Comment Code					
DT : Ditch					
Inspector Comment					
Concrete lined ditch runs along the levee toe.

View of the ditch on the landward side of the levee looking upstream.
Spring 2016.

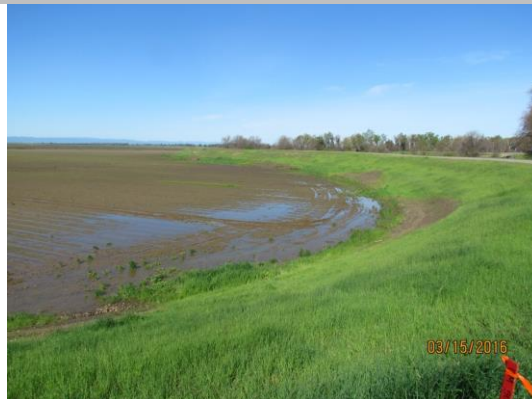
Photo 1 of 2 : FA_2016_NA0016_435_153_20160913_00079.jpg

LM Start	4.00	Rating **	U	Issue No.	153
LM End	4.15	Issue Type +	Ob	Location *	LS
Category	Earthen Levee			GPS Latitude/Longitude	
				Start	End
Item	Seepage / Sandboils			38.851382 °	38.851991 °
				-121.724708 °	-121.727000 °
DWR ID	DWR_NA0016_01_s_2016_153				
Comment Code					
Inspector Comment					
Seepage area has been staked and noted by LMA. Monitor seepage site.

View of the seepage on the landward side of the levee looking upstream. Spring 2016.

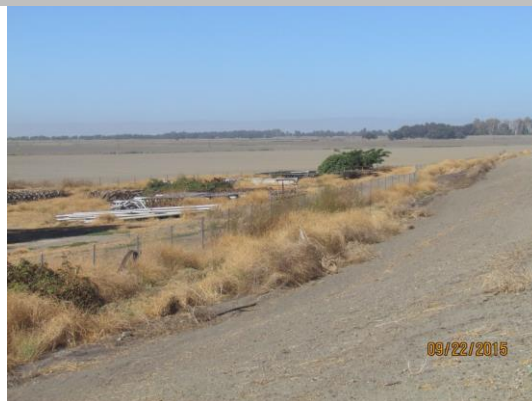
Photo 1 of 1 : FA_2016_NA0016_435_9_20160913_00009.jpg

View of the chain link fence along the landward levee toe looking upstream. The fence does not obstruct the view. Fall 2015.

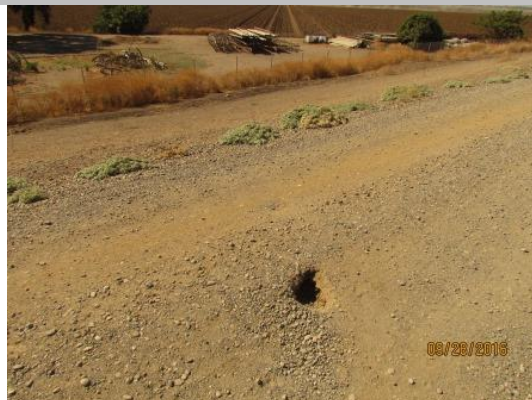
Photo 1 of 1 : FA_2016_NA0016_435_124_20160929_00237.jpg

View of an animal burrow on levee crown. Fall 2016 inspection.

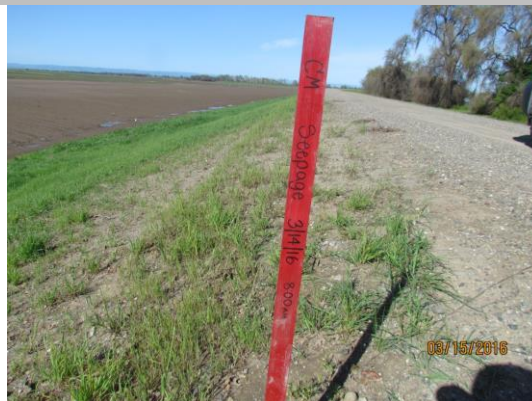
Photo 1 of 2 : FA_2016_NA0016_435_111_20160913_00055.jpg

LM Start	4.99	Rating **	U	Issue No.	111
LM End	5.09	Issue Type +	Ob	Location *	LS
Category	Earthen Levee			GPS Latitude/Longitude	
				Start	End
Item	Seepage / Sandboils			38.859909 °	38.860409 °
				-121.736119 °	-121.738001 °
DWR ID	DWR_NA0016_01_s_2016_111				
Comment Code					
Inspector Comment					
Seepage area has been staked and noted by LMA. Monitor seepage site.

Stake stating what date the seepage was last monitored. Spring 2016.

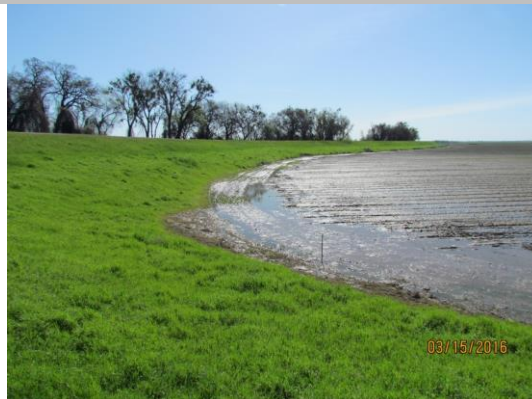
Photo 2 of 3 : FA_2016_NA0016_435_152_20160913_00077.jpg

LM Start	6.12	Rating **	U	Issue No.	152 (cont)	
LM End	6.12	Issue Type +	Ob	Location *	LS	
Category	Earthen Levee			GPS Latitude/Longitude		
				Start	End	
Item	Seepage / Sandboils			38.870503 °	38.870503 °	
				-121.750068 °	-121.750068 °	
DWR ID	DWR_NA0016_01_s_2016_152					
Comment Code						
Inspector Comment						
Seepage area has been staked and noted by LMA. Monitor seepage site.

View of the seepage on the landward side of the levee looking downstream. Spring 2016.

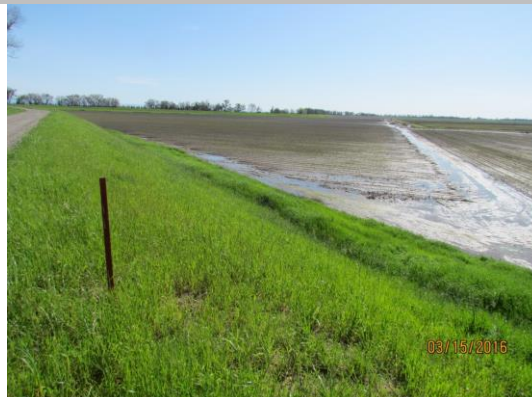
Photo 1 of 2 : FA_2016_NA0016_435_156_20160913_00082.jpg

LM Start	6.50	Rating **	U	Issue No.	156
LM End	6.62	Issue Type +	Ob	Location *	LS
Category	Earthen Levee			GPS Latitude/Longitude	
				Start	End
Item	Seepage / Sandboils			38.868127 °	38.867530 °
				-121.756499 °	-121.758427 °
DWR ID	DWR_NA0016_01_s_2016_156				
Comment Code					
Inspector Comment					
Seepage area has been staked and noted by LMA. Monitor seepage site.

View of the seepage on the landward side of the levee looking downstream. Spring 2016.

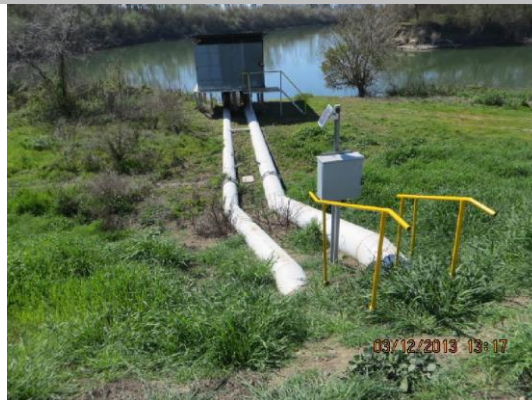
Photo 2 of 2 : UCIP_FA_2016_10129_17290.jpg

Comment Code						
Inspector Comment						
FS_ID:10129						
DS_ID:20228						
EP_NO: 1297						
Repair Type: Non-Urgent						
Crossing Status: Found						
UCIP Comments: Leak at flowmeter on WS berm may become problem in near future.						
FIELD_STRUCT_DESC: *REMOVED*2 of 2: 16-inch steel pipe through levee 5.2 feet below crown. Slant pumps in metal pump house on the waterward bank, supported on steel structure. Pipes discharge into 9.5'x12' concrete distribution box on the landward side. Sparline flow meter on pipes near the waterward toe. (Permit No. 1297, 1948). Also included in the 1960 O&M manual. Removed under permit No. 8501, 2012.						
FS Date: 3/12/2013

Pumphouse and steps on WS.

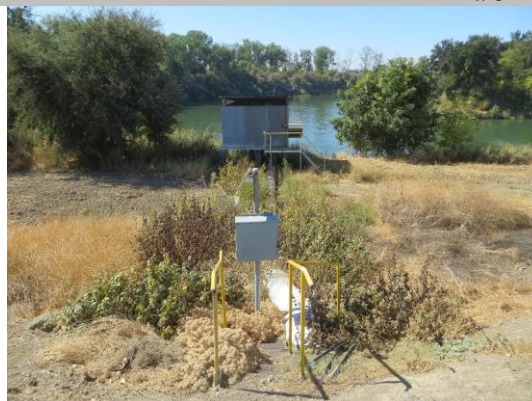
Photo 1 of 2 : UCIP_FA_2016_46765_74700.jpg

FS_ID:46765
DS_ID:25125
EP_NO: 8501
Repair Type: Non-Urgent
Crossing Status: Found
UCIP Comments: field inspection of the site revealed a few minor actions: 1. there are metal fence posts located near the pipe that should be cleared out for safety, 2. vegetation around the pipes should be cleared as it limits inspection, 3. some burrowing activity was noticed nearby the pipes.
FIELD_STRUCT_DESC: A 20 inch steel pipe and a 16 inch steel pipe are located at levee mile 6.889 and 6.89, respectively. Both pipes have a protective paint coating. The pipes are used to supply irrigation water to the adjacent fields. On the water side of the levee, the pipes are above ground and follow the slope of the bank into the river. A metal pumphouse, supported on a steel frame is located on a bench on the waterside of the levee. When the pumps are operational a drum fish screen is lowered over the pipe intakes on a track. Both irrigation pipes travel through the levee and have siphon breakers in CMP risers on the land side crest of the levee. The pipes discharge under submerged conditions to a 9.5 ft x 12 ft concrete distribution box. There are two gated outlets on the distribution box that lead to distribution canals.

view from levee crest along pipe profile on water side of levee. pipe daylight from levee and pumphouse.

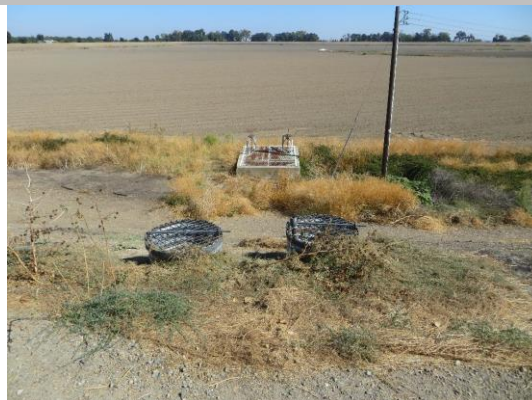
Photo 2 of 2 : UCIP_FA_2016_46766_74706.jpg

FS_ID:46766
DS_ID:25126
EP_NO: 8501
Repair Type: Non-Urgent
Crossing Status: Found
UCIP Comments: a few actions are recommended based on field inspection: 1. clear out metal fence posts near daylight of pipe on water side levee. 2. clear vegetation around pipes on water side of levee to aid in inspection. 3. monitor burrowing activities on water side of levee.
FIELD_STRUCT_DESC: A 20 inch steel pipe and a 16 inch steel pipe are located at levee mile 6.889 and 6.89, respectively. Both pipes have a protective paint coating. The pipes are used to supply irrigation water to the adjacent fields. On the water side of the levee, the pipes are above ground and follow the slope of the bank into the river. A metal pumphouse, supported on a steel frame is located on a bench on the waterside of the levee. When the pumps are operational a drum fish screen is lowered over the pipe intakes on a track. Both irrigation pipes travel through the levee and have siphon breakers in CMP risers on the land side crest of the levee. The pipes discharge under submerged conditions to a 9.5 ft x 12 ft concrete distribution box. There are two gated outlets on the distribution box that lead to distribution canals.

view from levee crest along pipe looking towards land side. shows siphon breaker standpipes and distribution box.

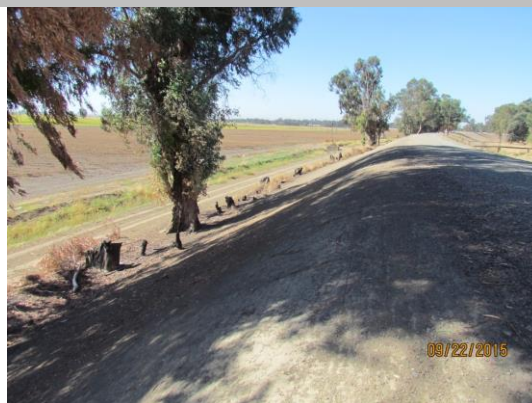
Photo 1 of 1 : FA_2016_NA0016_435_116_20160913_00060.jpg

LM Start	7.80	Rating **	N	Issue No.	116
LM End	8.64	Issue Type +	Ma	Location *	LS
Category	Earthen Levee			GPS Latitude/Longitude	
				Start	End
Item	Trim / Thin Trees			38.861357°	38.856379°
				-121.768641°	-121.781943°
DWR ID	DWR_NA0016_01_f_2015_116				
Comment Code					
T5 : Tree stumps.					
Inspector Comment

View of the tree stumps along the landward levee toe looking upstream.
Fall 2015.

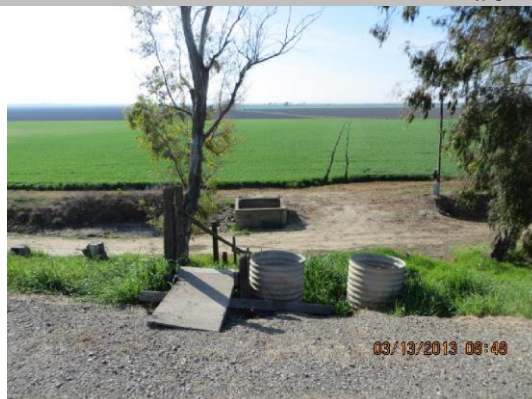
Photo 1 of 2 : UCIP_FA_2016_10144_17307.jpg

LM Start	7.86	Rating **	M	Issue No.	1582
LM End	7.86	Issue Type +	En	Location *	LS
Category	Supplemental			GPS Latitude/Longitude	
				Start	End
Item	DWR UCIP Field Study			38.861018 °	38.861018 °
				-121.769651 °	-121.769651 °
DWR ID					
Comment Code					
Inspector Comment					
FS_ID:10144 DS_ID:20428 EP_NO: 18206 Repair Type: Non-Urgent Crossing Status: Found UCIP Comments: Flap gates rusted through at concrete distribution box on LS toe. FIELD_STRUCT_DESC: 1 of 2: 20-inch steel pipe through levee 4.7 feet below crown (Permit No. 18206, 2007). Two slant pumps in pump house on the waterward berm. Siphon breakers in corrugated metal riser units on the shoulder. Flap gate on both pipes in concrete distribution box on the landward side. Wooden steps on both slopes. Replaced 20-inch pipe installed under Permit No. 9377. FS Date: 3/13/2013

Stairs, distribution box, and air vent in CMP riser on LS.

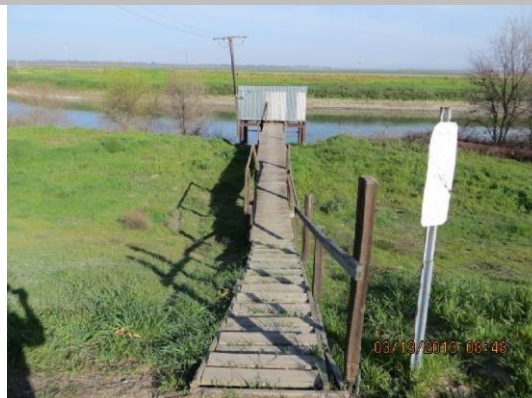
Photo 2 of 2 : UCIP_FA_2016_10144_17306.jpg

Stairs and pump on WS.

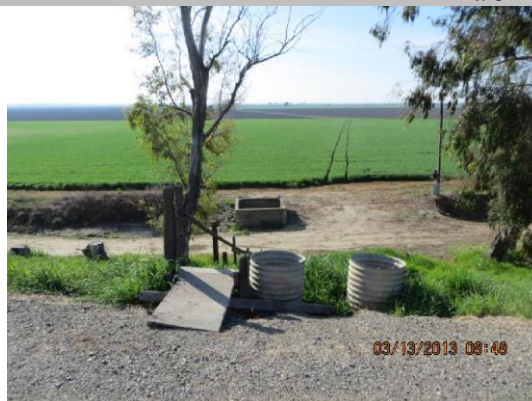
Photo 1 of 2 : UCIP_FA_2016_10143_17302.jpg

LM Start	7.86	Rating **	M	Issue No.	1581
LM End	7.86	Issue Type +	En	Location *	LS
Category	Supplemental			GPS Latitude/Longitude	
				Start	End
Item	DWR UCIP Field Study			38.861017 °	38.861017 °
				-121.769658 °	-121.769658 °
DWR ID					
Comment Code					
Inspector Comment					
FS_ID:10143 DS_ID:20427 EP_NO: 18206 Repair Type: Non-Urgent Crossing Status: Found UCIP Comments: Flap gates rusted through at LS distribution box. FIELD_STRUCT_DESC: 2 of 2: 16-inch steel pipe through levee 4.7 feet below crown (Permit No. 18206, 2007). Two slant pumps in pump house on the waterward berm. Siphon breakers in corrugated metal riser units on the shoulder. Flap gate on both pipes in concrete distribution box on the landward side. Wooden steps on both slopes. Replaced 16-inch pipe installed under Permit No. 9377. FS Date: 3/13/2013

Steps, air vent in riser, and distribution box on LS.

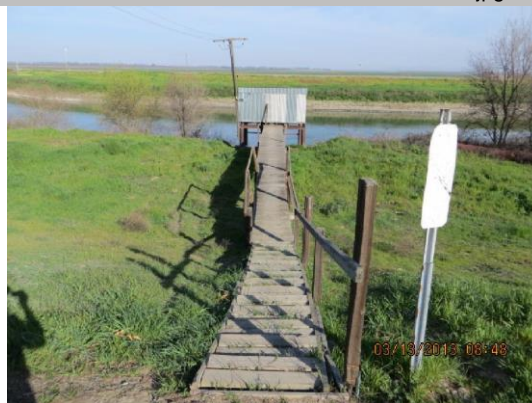
Photo 2 of 2 : UCIP_FA_2016_10143_17301.jpg

Stairs, pump platform on WS.

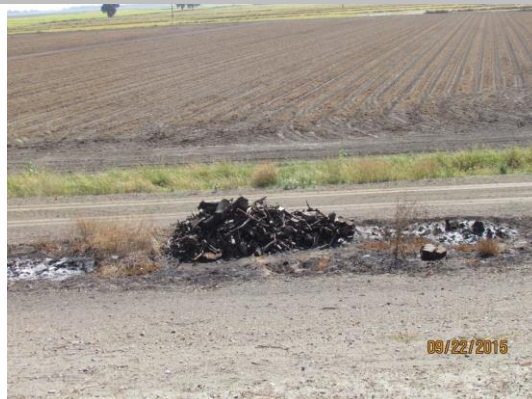
Photo 1 of 1 : FA_2016_NA0016_435_118_20160913_00062.jpg

LM Start	8.45	Rating **	M	Issue No.	118
LM End	8.45	Issue Type +	En	Location *	LS
Category	Earthen Levee			GPS Latitude/Longitude	
				Start	End
Item	Encroachments			38.858559 °	38.858559 °
				-121.779689 °	-121.779689 °
DWR ID	DWR_NA0016_01_f_2015_118				
Comment Code					
FW : Firewood					
Inspector Comment

View of the wood pile on the landward side of the levee. Fall 2015.

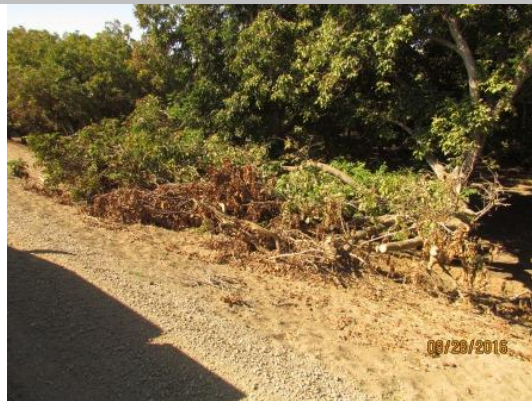
Photo 1 of 1 : FA_2016_NA0016_435_123_20160929_00238.jpg

LM Start	9.09	Rating **	M	Issue No.	123
LM End	9.09	Issue Type +	En	Location *	LS
Category	Earthen Levee			GPS Latitude/Longitude	
				Start	End
Item	Encroachments			38.859320 °	38.859320 °
				-121.784939 °	-121.784939 °
DWR ID	DWR_NA0016_01_f_2016_123				
Comment Code					
TR : Tree or limb					
Inspector Comment

Tree limbs on landside slope. Fall 2016 inspection.

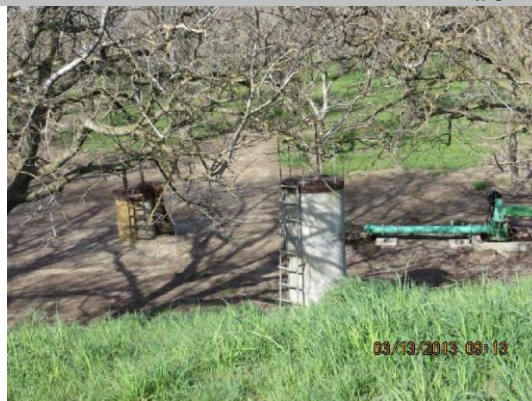
Photo 1 of 2 : UCIP_FA_2016_50039_17328.jpg

LM Start	9.21	Rating **	M	Issue No.	1589 (cont)
LM End	9.21	Issue Type +	En	Location *	LS

Concrete riser on LS toe.

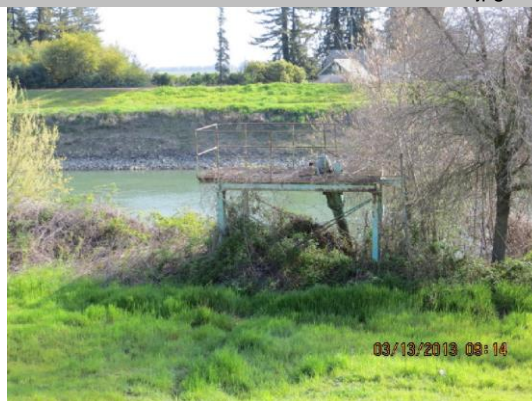
Photo 2 of 2 : UCIP_FA_2016_50039_17327.jpg

Pump platform on WS.

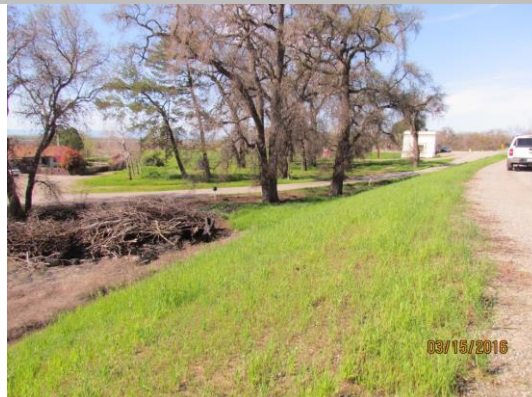
Photo 1 of 1 : FA_2016_NA0016_435_160_20160913_00085.jpg

LM Start	9.67	Rating **	M	Issue No.	160
LM End	9.67	Issue Type +	En	Location *	LS
Category	Earthen Levee			GPS Latitude/Longitude	
				Start	End
Item	Encroachments			38.862279 °	38.862279 °
				-121.791088 °	-121.791088 °
DWR ID	DWR_NA0016_01_s_2016_160				
Comment Code					
PR : Prunings					
Inspector Comment

View of the pruning pile on the landward side of the levee looking upstream. Spring 2016.

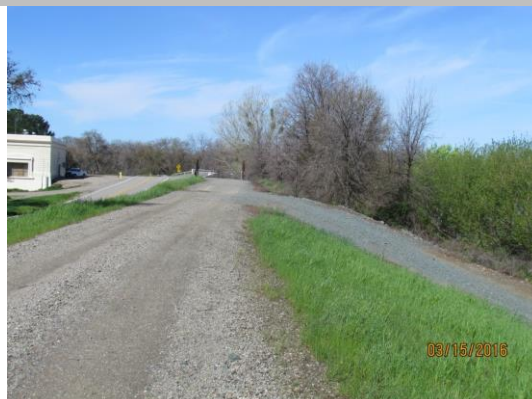
Photo 1 of 2 : FA_2016_NA0016_435_29_20160913_00021.jpg

LM Start	9.68	Rating **	A/W	Issue No.	29
LM End	9.79	Issue Type +	Ma	Location *	WS
Category	Earthen Levee			GPS Latitude/Longitude	
				Start	End
Item	Vegetation			38.862345 °	38.862848 °
				-121.791337 °	-121.793267 °
DWR ID	DWR_NA0016_01_s_2012_29				
Comment Code					
V8 : Environmental Requirements.					
Inspector Comment

View of the revegetation site on the waterward side of the levee looking upstream. Spring 2016.

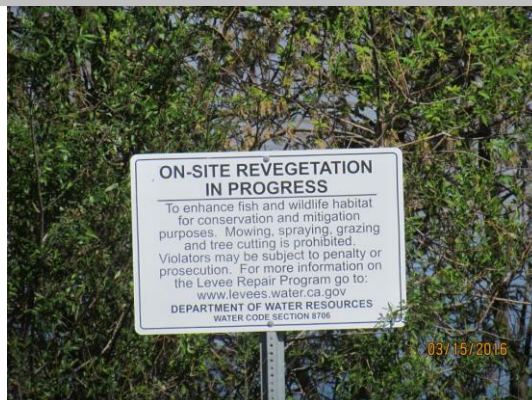
Photo 2 of 2 : FA_2016_NA0016_435_29_20160913_00022.jpg

Revegetation site sign. Spring 2016.

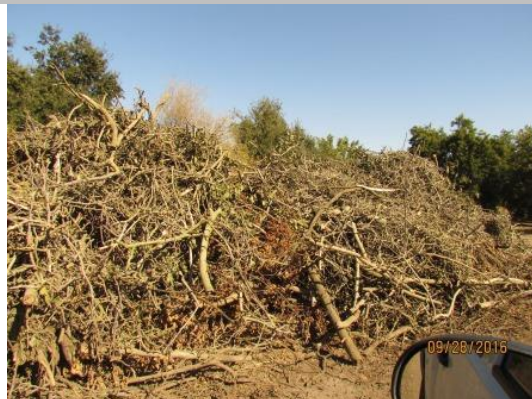
Photo 1 of 1 : FA_2016_NA0016_435_122_20160929_00239.jpg

LM Start	10.18	Rating **	M	Issue No.	122
LM End	10.18	Issue Type +	En	Location *	WS
Category	Earthen Levee			GPS Latitude/Longitude	
				Start	End
Item	Encroachments			38.865016 °	38.865016 °
				-121.798082 °	-121.798082 °
DWR ID	DWR_NA0016_01_f_2016_122				
Comment Code					
PR : Prunings					
Inspector Comment

Tree prunings on WS slope. Fall 2016 inspection.

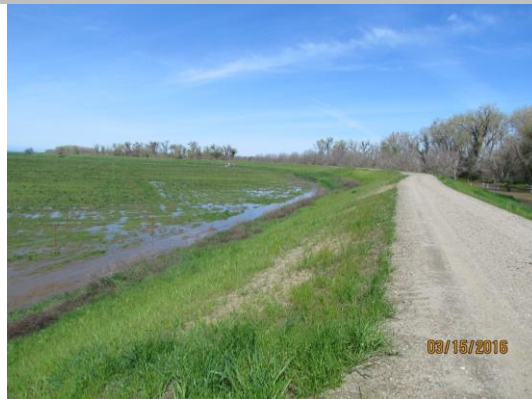
Photo 1 of 2 : FA_2016_NA0016_435_163_20160913_00088.jpg

LM Start	10.69	Rating **	U	Issue No.	163
LM End	10.91	Issue Type +	Ob	Location *	LS
Category	Earthen Levee			GPS Latitude/Longitude	
				Start	End
Item	Seepage / Sandboils			38.866965 °	38.869808 °
				-121.803600 °	-121.804722 °
DWR ID	DWR_NA0016_01_s_2016_163				
Comment Code					
Inspector Comment					
Seepage area has been staked and noted by LMA. Monitor seepage site.

View of the seepage on the landward side of the levee looking upstream. Spring 2016.

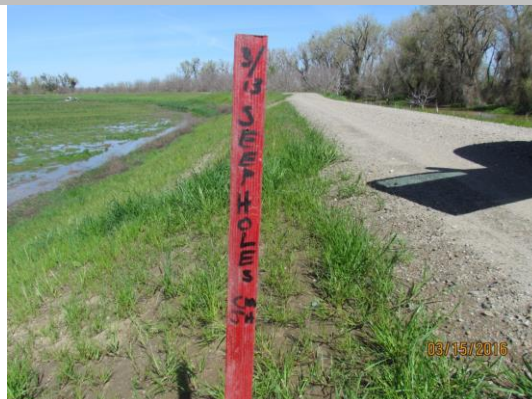
Photo 2 of 2 : FA_2016_NA0016_435_163_20160913_00089.jpg

Stake is planted on the shoulder of the levee on the landward side. Spring 2016.

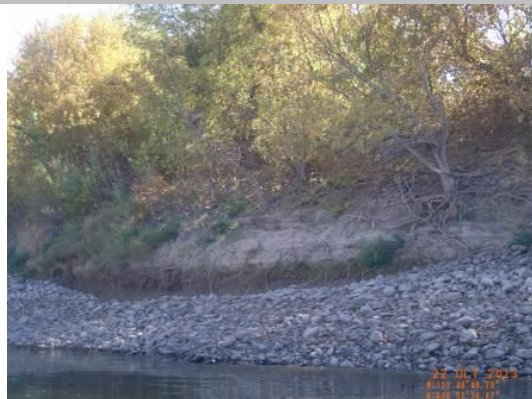
Photo 1 of 1 : FA_2016_NA0016_435_7_20160913_00007.jpg

LM Start	11.50	Rating **	M	Issue No.	7
LM End	11.53	Issue Type +	Ma	Location *	WS
Category	Supplemental			GPS Latitude/Longitude	
				Start	End
Item	2015 USACE Erosion Survey, DRAFT			38.874854 °	38.875109 °
				-121.813018 °	-121.813592 °
DWR ID	DWR_NA0016_01_s_2016_7				
Comment Code					
Inspector Comment					
1997 - Toe damage and loss of cobble revetment and small patch of local damage to the cobble revetment. 2000 - Cohesive vertical toe; revegetation site. 2015: No observed changes. [2015 Site ID: SAC_101-3_R]

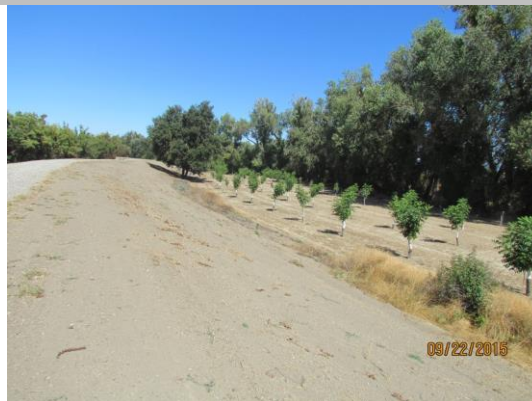
Photo 1 of 1 : FA_2016_NA0016_435_966_20160913_00126.jpg

LM Start	11.71	Rating **	U	Issue No.	966
LM End	11.71	Issue Type +	En	Location *	WS
Category	Earthen Levee			GPS Latitude/Longitude	
				Start	End
Item	Encroachments			38.876865 °	38.876865 °
				-121.816095 °	-121.816095 °
DWR ID	DWR_NA0016_01_s_2012_966				
Comment Code					
CR : Crops					
Inspector Comment					
New walnut orchard between toe and river with approximately 80-90 trees.

View of the walnut orchard planted on the waterward side of the levee looking upstream. Fall 2015.

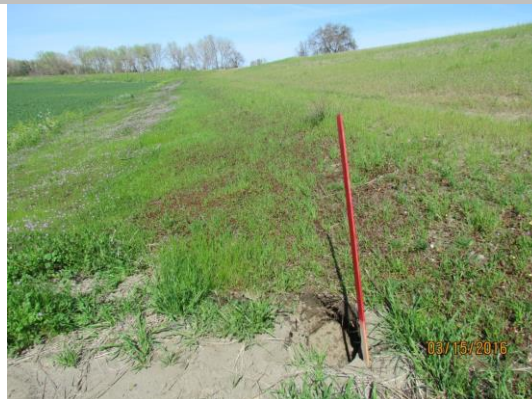
Photo 1 of 2 : FA_2016_NA0016_435_167_20160913_00094.jpg

LM Start	13.98	Rating **	U	Issue No.	167	
LM End	13.98	Issue Type +	Ma	Location *	LS	
Category	Earthen Levee			GPS Latitude/Longitude		
				Start		End
Item	Animal Control			38.904886 °		38.904886 °
				-121.806490 °		-121.806490 °
DWR ID	DWR_NA0016_01_s_2016_167					
Comment Code						
A2 : Repair the levee slope damaged by livestock and prevent large animal access.						
Inspector Comment						
Foxhole is close to the levee toe.

Perspective view of the fox hole on the landward side of the levee looking upstream. Spring 2016.

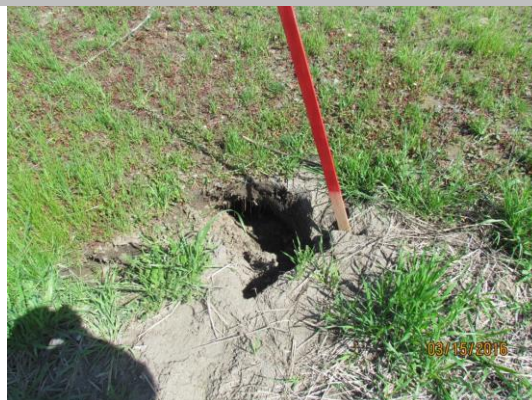
Photo 2 of 2 : FA_2016_NA0016_435_167_20160913_00095.jpg

Fox hole is close to the toe of the levee. Spring 2016.

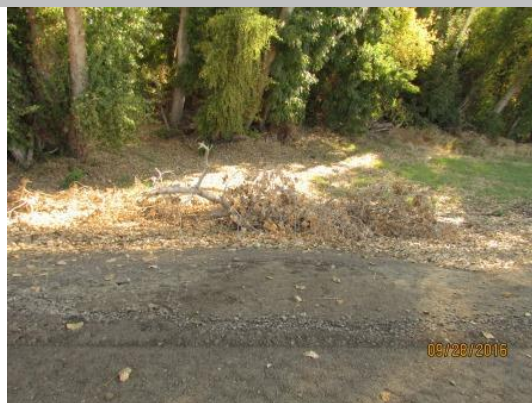
Photo 1 of 1 : FA_2016_NA0016_435_120_20160929_00240.jpg

LM Start	14.72	Rating **	M	Issue No.	120
LM End	14.72	Issue Type +	Ma	Location *	WS
Category	Earthen Levee			GPS Latitude/Longitude	
				Start	End
Item	Encroachments			38.911576 °	38.911576 °
				-121.816376 °	-121.816376 °
DWR ID	DWR_NA0016_01_f_2016_120				
Comment Code					
PR : Prunings					
Inspector Comment

View of prunings on waterside slope. Fall 2016 inspection.

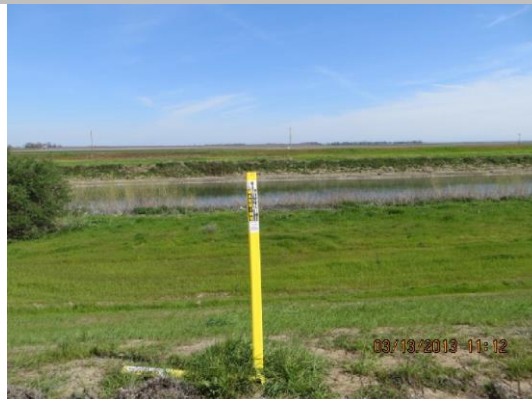
Photo 1 of 2 : UCIP_FA_2016_10203_17399.jpg

LM Start	16.22	Rating **	M	Issue No.	1561
LM End	16.22	Issue Type +	En	Location *	CR
Category	Supplemental			GPS Latitude/Longitude	
				Start	End
Item	DWR UCIP Field Study			38.923407 °	38.923407 °
				-121.834588 °	-121.834588 °
DWR ID					
Comment Code					
Inspector Comment					
FS_ID:10203					
DS_ID:20432					
EP_NO: N/A					
Repair Type: Non-Urgent					
Crossing Status: Found					
UCIP Comments: Need to determine if this is a permitted crossing as it was not previously noted. Need to determine size and depth below the crown.					
FIELD_STRUCT_DESC: Gas line through levee at unknown depth below the crown. Marker on WS shoulder.					
FS Date: 3/13/2013

Gasline marker on WS shoulder.

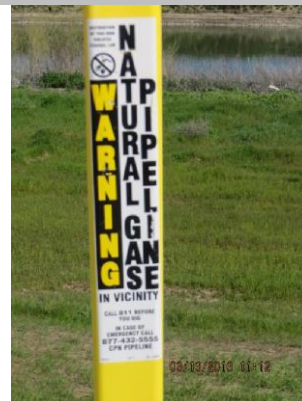
Photo 2 of 2 : UCIP_FA_2016_10203_17398.jpg

Gasline marker on WS shoulder.

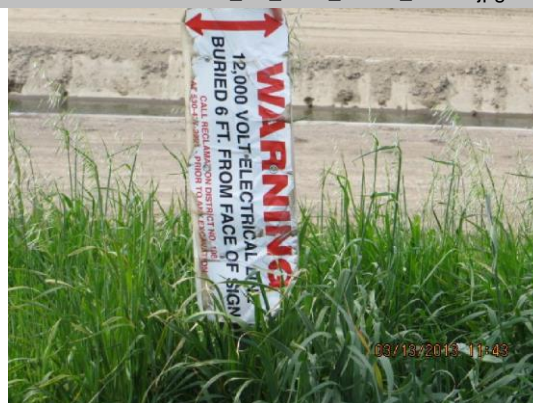
Photo 1 of 1 : UCIP_FA_2016_11323_18720.jpg

LM Start	17.94	Rating **	M	Issue No.	1554
LM End	17.94	Issue Type +	En	Location *	CR
Category	Supplemental			GPS Latitude/Longitude	
				Start	End
Item	DWR UCIP Field Study			38.942979 °	38.942979 °
				-121.837030 °	-121.837030 °
DWR ID					
Comment Code					
Inspector Comment					
FS_ID:11323 DS_ID:22957 EP_NO: 18026 Repair Type: Non-Urgent Crossing Status: Found UCIP Comments: Conduit needs to be located and signs installed where it crosses the levee crown. FIELD_STRUCT_DESC: Electric Conduit through the levee at unknown depth. Signage on LS shoulder. (Permit No. 18026, 2007) FS Date: 3/13/2013

Sign on LS shoulder.

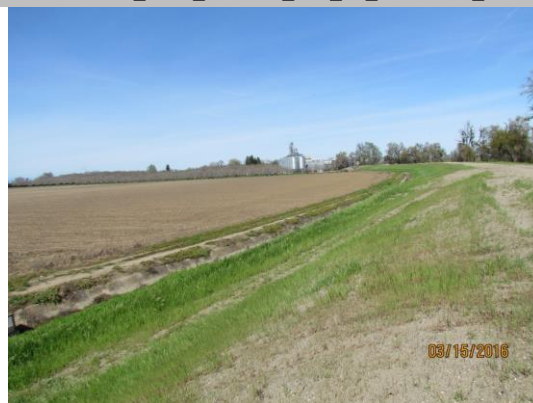
Photo 1 of 1 : FA_2016_NA0016_435_15_20160913_00014.jpg

LM Start	18.20	Rating **	M	Issue No.	15
LM End	18.46	Issue Type +	En	Location *	LS
Category	Earthen Levee			GPS Latitude/Longitude	
				Start	End
Item	Encroachments			38.946674 °	38.950263 °
				-121.837528 °	-121.837768 °
DWR ID	DWR_NA0016_01_s_2012_15				
Comment Code					
DT : Ditch					
Inspector Comment					
Concrete lined ditch runs along the toe of the levee.

View of the ditch on the landward side of the levee looking upstream. Spring 2016.

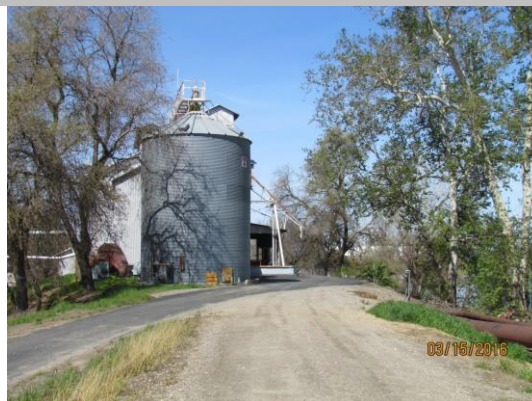
Photo 1 of 1 : FA_2016_NA0016_435_16_20160913_00015.jpg

LM Start	18.54	Rating **	M	Issue No.	16
LM End	18.54	Issue Type +	En	Location *	CR
Category	Earthen Levee			GPS Latitude/Longitude	
				Start	End
Item	Encroachments			38.951400 °	38.951400 °
				-121.838255 °	-121.838255 °
DWR ID	DWR_NA0016_01_s_2012_16				
Comment Code					
BU : Building					
Inspector Comment

View of the rice mill on the crown of the levee looking upstream. Spring 2016.

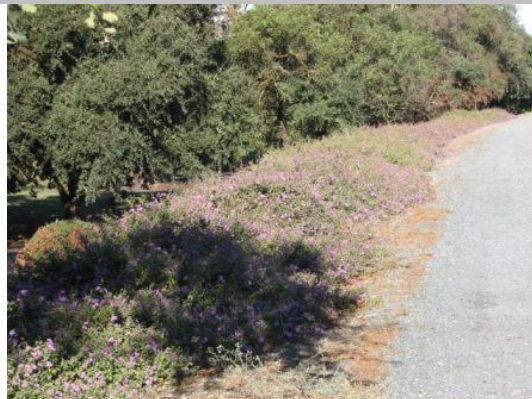
Photo 1 of 1 : FA_2016_NA0016_435_18_20160913_00017.jpg

LM Start	18.54	Rating **	M	Issue No.	18
LM End	18.54	Issue Type +	En	Location *	WS
Category	Earthen Levee			GPS Latitude/Longitude	
				Start	End
Item	Vegetation			38.951464 °	38.951464 °
				-121.838293 °	-121.838293 °
DWR ID	DWR_NA0016_01_s_2012_18				
Comment Code					
V6 : Landscaping					
Inspector Comment

Groundcover and trees with irrigation are planted on the levee slope. Fall 2011.

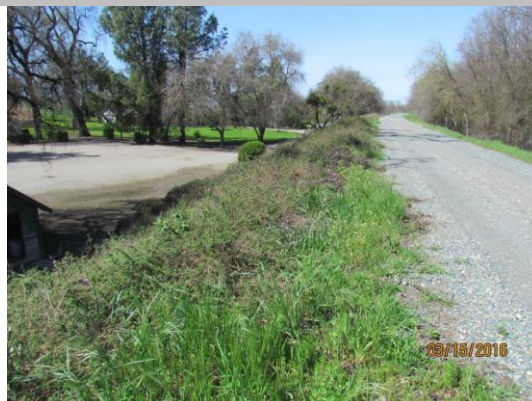
Photo 1 of 2 : FA_2016_NA0016_435_173_20160913_00097.jpg

LM Start	18.66	Rating **	M	Issue No.	173
LM End	18.71	Issue Type +	En	Location *	LS
Category	Earthen Levee			GPS Latitude/Longitude	
				Start	End
Item	Vegetation			38.952765 °	38.953295 °
				-121.839661 °	-121.840241 °
DWR ID	DWR_NA0016_01_s_2016_173				
Comment Code					
V6 : Landscaping					
Inspector Comment

View of the landscaping on the landward side of the levee looking upstream. Spring 2016.

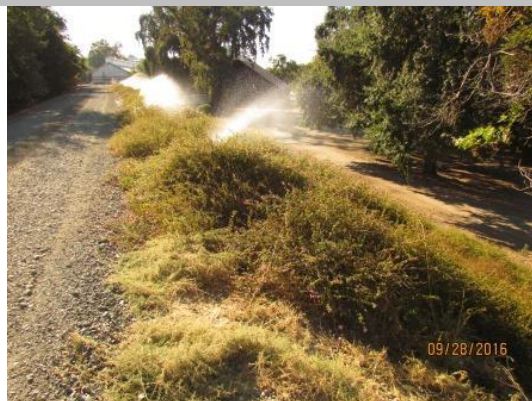
Photo 2 of 2 : FA_2016_NA0016_435_173_20160929_00241.jpg

LM Start	18.66	Rating **	M	Issue No.	173 (cont)	
LM End	18.71	Issue Type +	En	Location *	LS	
Category	Earthen Levee			GPS Latitude/Longitude		
				Start		End
Item	Vegetation			38.952765 °		38.953295 °
				-121.839661 °		-121.840241 °
DWR ID	DWR_NA0016_01_s_2016_173					
Comment Code						
V6 : Landscaping						
Inspector Comment

Irrigated landscaping on landside slope of the levee reaching levee crown. Fall 2016 inspection.

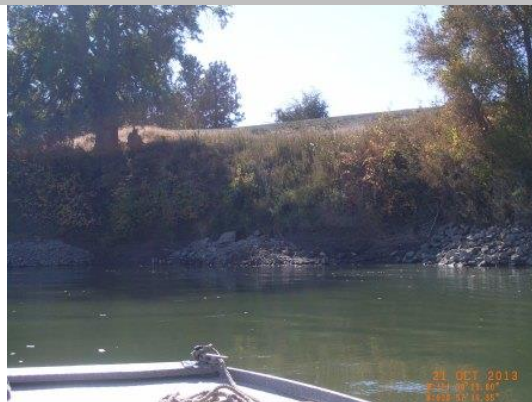
Photo 1 of 1 : FA_2016_NA0016_435_10_20160913_00010.jpg

LM Start	18.76	Rating **	M	Issue No.	10
LM End	18.78	Issue Type +	Ma	Location *	WS
Category	Supplemental			GPS Latitude/Longitude	
				Start	End
Item	2015 USACE Erosion Survey, DRAFT			38.954060 °	38.954312 °
				-121.840560 °	-121.840774 °
DWR ID	DWR_NA0016_01_s_2016_10				
Comment Code					
Inspector Comment					
2009 - Minor erosion, should be repaired under maintenance. 2011 - Some new minor erosion at the toe. 2015: No observed changes. [2015 Site ID: SAC_111-0_R]

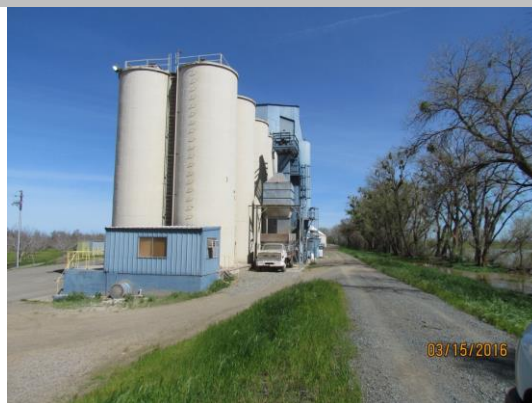
Photo 1 of 1 : FA_2016_NA0016_435_23_20160913_00019.jpg

LM Start	18.99	Rating **	M	Issue No.	23
LM End	18.99	Issue Type +	En	Location *	CR
Category	Earthen Levee			GPS Latitude/Longitude	
				Start	End
Item	Encroachments			38.956347 °	38.956347 °
				-121.839503 °	-121.839503 °
DWR ID	DWR_NA0016_01_s_2012_23				
Comment Code					
BU : Building					
Inspector Comment

View of the rice mill on the crown of the levee looking upstream. Spring 2016.

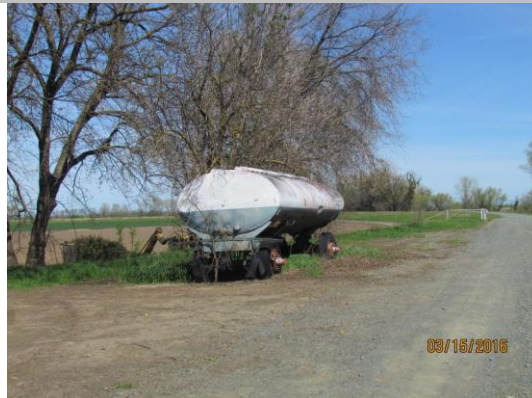
Photo 1 of 1 : FA_2016_NA0016_435_26_20160913_00020.jpg

LM Start	19.12	Rating **	M	Issue No.	26
LM End	19.12	Issue Type +	En	Location *	LS
Category	Earthen Levee			GPS Latitude/Longitude	
				Start	End
Item	Encroachments			38.957180 °	38.957180 °
				-121.837442 °	-121.837442 °
DWR ID	DWR_NA0016_01_s_2012_26				
Comment Code					
EQ : Equipment					
Inspector Comment

View of the equipment on the crown of the levee looking upstream.
Beehives have been removed. Spring 2016.

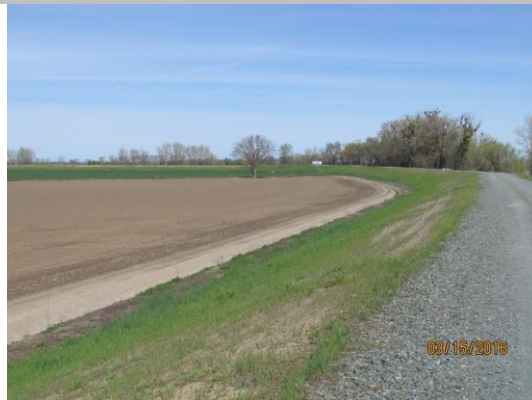
Photo 1 of 2 : FA_2016_NA0016_435_31_20160913_00025.jpg

LM Start	19.15	Rating **	M	Issue No.	31
LM End	19.61	Issue Type +	En	Location *	LS
Category	Earthen Levee			GPS Latitude/Longitude	
				Start	End
Item	Encroachments			38.957405 °	38.962648 °
				-121.836965 °	-121.834368 °
DWR ID	DWR_NA0016_01_s_2012_31				
Comment Code					
DT : Ditch					
Inspector Comment					
Concrete lined ditch up to LM 19.40. Soil ditch continues on until LM 19.61.

View of the ditch on the landward side of the levee looking upstream.
Spring 2016.

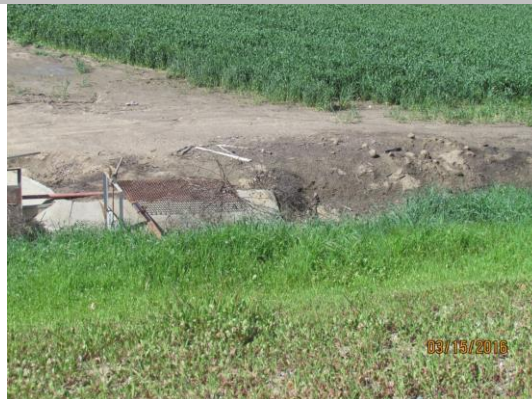
Photo 2 of 2 : FA_2016_NA0016_435_31_20160913_00026.jpg

LM Start	19.15	Rating **	M	Issue No.	31 (cont)	
LM End	19.61	Issue Type +	En	Location *	LS	
Category	Earthen Levee			GPS Latitude/Longitude		
				Start		End
Item	Encroachments			38.957405 °		38.962648 °
				-121.836965 °		-121.834368 °
DWR ID	DWR_NA0016_01_s_2012_31					
Comment Code						
DT : Ditch						
Inspector Comment						
Concrete lined ditch up to LM 19.40. Soil ditch continues on until LM 19.61.

Concrete lined ditch stops at levee mile 19.40.

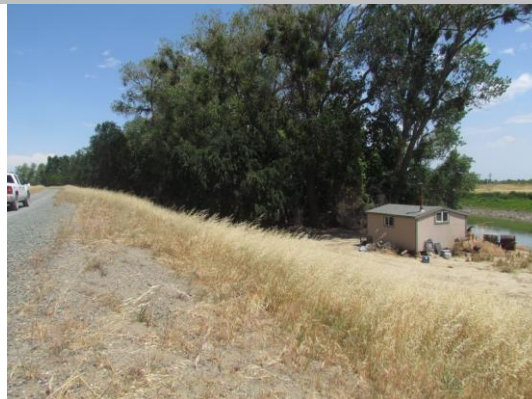
Photo 1 of 1 : FA_2016_NA0016_435_96_20160913_00040.jpg

LM Start	19.37	Rating **	M	Issue No.	96
LM End	19.37	Issue Type +	En	Location *	WS
Category	Earthen Levee			GPS Latitude/Longitude	
				Start	End
Item	Encroachments			38.959642 °	38.959642 °
				-121.834004 °	-121.834004 °
DWR ID	DWR_NA0016_01_s_2015_96				
Comment Code					
BU : Building					
Inspector Comment

View of the building on the waterward side of the levee looking upstream. Spring 2015.

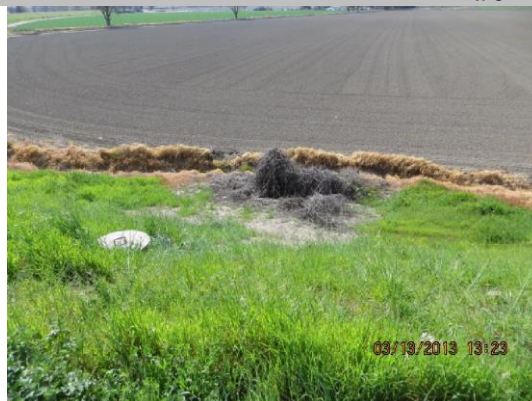
Photo 1 of 2 : UCIP_FA_2016_10253_17449.jpg

LM Start	19.50	Rating **	M	Issue No.	1568
LM End	19.50	Issue Type +	En	Location *	WS
Category	Supplemental			GPS Latitude/Longitude	
				Start	End
Item	DWR UCIP Field Study			38.961221 °	38.961221 °
				-121.833230 °	-121.833230 °
DWR ID					
Comment Code					
Inspector Comment					
FS_ID:10253 DS_ID:20246 EP_NO: 1507 Repair Type: Non-Urgent Crossing Status: Found UCIP Comments: Pipe appears abandoned. Needs to be abandoned properly. FIELD_STRUCT_DESC: 14-inch steel irrigation pipe through levee 8.4 feet below crown. Gate valve on the waterward side, siphon breaker in 24-inch CMP riser on the landward slope. Concrete distribution box in irrigation ditch at the toe of the landward slope (Permit No. 1507, 1959). Included in the 1960 O&M manual. FS Date: 3/13/2013

CMP Riser on shoulder and concrete distribution box under heavy blackberry cover at LS toe.

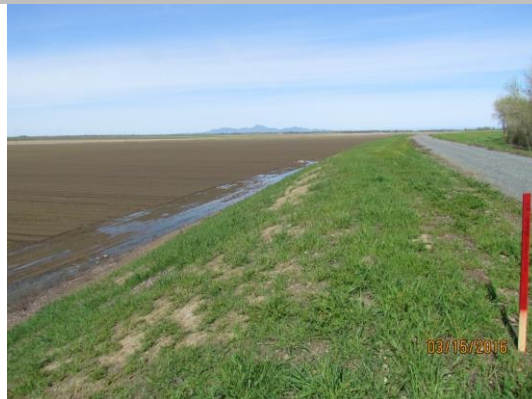
Photo 1 of 2 : FA_2016_NA0016_435_176_20160913_00098.jpg

LM Start	20.07	Rating **	U	Issue No.	176
LM End	20.21	Issue Type +	Ob	Location *	LS
Category	Earthen Levee			GPS Latitude/Longitude	
				Start	End
Item	Seepage / Sandboils			38.968952 °	38.970733 °
				-121.835239 °	-121.833896 °
DWR ID	DWR_NA0016_01_s_2016_176				
Comment Code					
Inspector Comment					
Seepage area has been staked and noted by LMA. Monitor seepage site.

View of the seepage on the landward side of the levee looking upstream. Spring 2016.

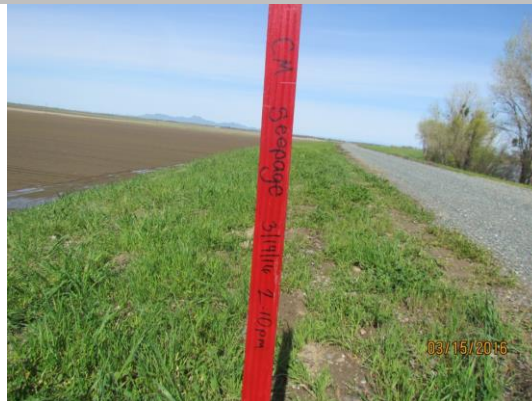
Photo 2 of 2 : FA_2016_NA0016_435_176_20160913_00099.jpg

LM Start	20.07	Rating **	U	Issue No.	176 (cont)
LM End	20.21	Issue Type +	Ob	Location *	LS

Monitoring stake for the seepage. Spring 2016.

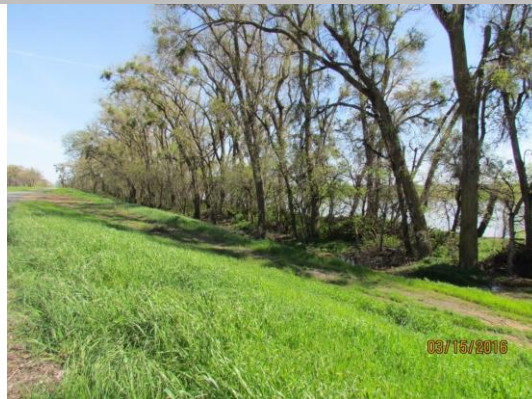
Photo 2 of 2 : FA_2016_NA0016_435_30_20160913_00024.jpg

LM Start	22.12	Rating **	A/W	Issue No.	30 (cont)	
LM End	22.42	Issue Type +	Ob	Location *	WS	
Category	Earthen Levee			GPS Latitude/Longitude		
				Start		End
Item	Vegetation			38.989528 °		38.989722 °
				-121.816020 °		-121.810488 °
DWR ID	DWR_NA0016_01_s_2012_30					
Comment Code						
V8 : Environmental Requirements.						
Inspector Comment

View of the revegetation on the waterward berm of the levee looking upstream. Spring 2016.

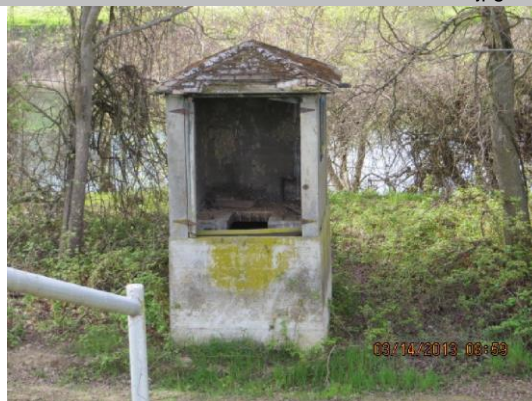
Photo 1 of 2 : UCIP_FA_2016_10266_17490.jpg

LM Start	22.71	Rating **	M	Issue No.	1576
LM End	22.71	Issue Type +	En	Location *	WS
Category	Supplemental			GPS Latitude/Longitude	
				Start	End
Item	DWR UCIP Field Study			38.989862 °	38.989862 °
				-121.805243 °	-121.805243 °
DWR ID					
Comment Code					
Inspector Comment					
FS_ID:10266					
DS_ID:20248					
EP_NO: N/A					
Repair Type: Non-Urgent					
Crossing Status: Found					
UCIP Comments: Pipe needs to be verified as having been properly abandoned.					
FIELD_STRUCT_DESC: 24-inch pipe through levee 19.5 feet below crown. Abandoned concrete pumphouse on waterward toe. Originally included in the 1960 O&M manual.					
FS Date: 3/14/2013

Concrete pumphouse on WS berm.

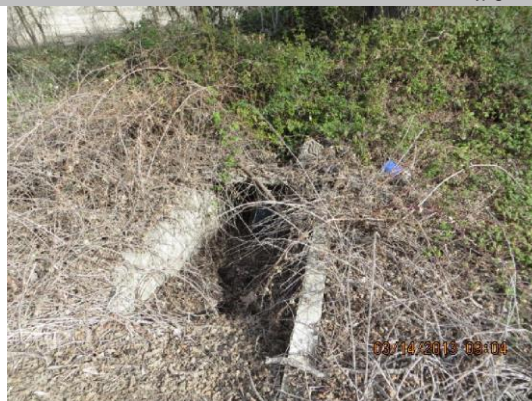
Photo 2 of 2 : UCIP_FA_2016_10266_17489.jpg

LM Start	22.71	Rating **	M	Issue No.	1576 (cont)
LM End	22.71	Issue Type +	En	Location *	WS
Category	Supplemental			GPS Latitude/Longitude	
				Start	End
Item	DWR UCIP Field Study			38.989862 °	38.989862 °
				-121.805243 °	-121.805243 °
DWR ID					
Comment Code					
Inspector Comment					
FS_ID:10266 DS_ID:20248 EP_NO: N/A Repair Type: Non-Urgent Crossing Status: Found UCIP Comments: Pipe needs to be verified as having been properly abandoned. FIELD_STRUCT_DESC: 24-inch pipe through levee 19.5 feet below crown. Abandoned concrete pumphouse on waterward toe. Originally included in the 1960 O&M manual. FS Date: 3/14/2013

Concrete box on LS toe.

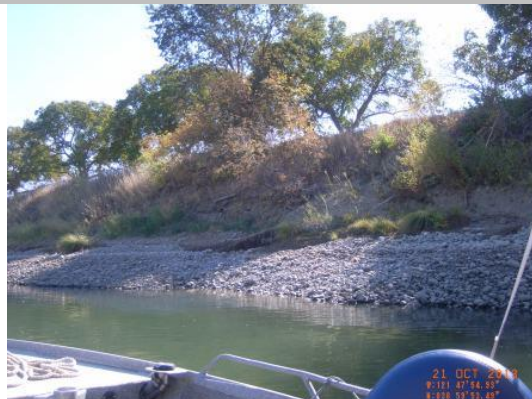
Photo 1 of 1 : FA_2016_NA0016_435_11_20160913_00011.jpg

LM Start	23.55	Rating **	M	Issue No.	11
LM End	23.65	Issue Type +	Ma	Location *	WS
Category	Supplemental			GPS Latitude/Longitude	
				Start	End
Item	2015 USACE Erosion Survey, DRAFT			38.997696 °	38.998336 °
				-121.797584 °	-121.799298 °
DWR ID	DWR_NA0016_01_s_2016_11				
Comment Code					
Inspector Comment					
2008 - Slippage of cobbles off hard underlying toe material. 2011 - Minor slumping site. 2012 - Failing cobble site, site extended upstream. 2015: No observed changes. [2015 Site ID: SAC_115-9_R]

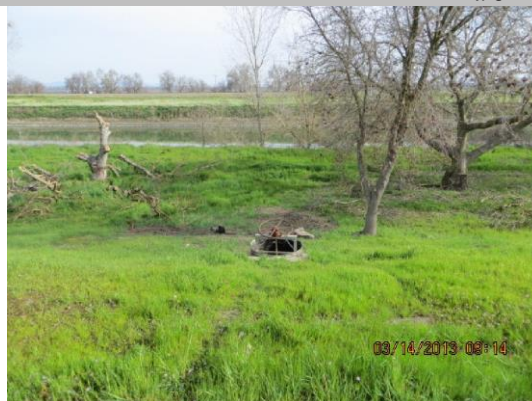
Photo 1 of 2 : UCIP_FA_2016_10261_17466.jpg

LM Start	23.70	Rating **	M	Issue No.	1569
LM End	23.70	Issue Type +	En	Location *	WS
Category	Supplemental			GPS Latitude/Longitude	
				Start	End
Item	DWR UCIP Field Study			38.998247 °	38.998247 °
				-121.800236 °	-121.800236 °
DWR ID					
Comment Code					
Inspector Comment					
FS_ID:10261 DS_ID:20249 EP_NO: 9374 Repair Type: Non-Urgent Crossing Status: Found UCIP Comments: Appears abandoned. Pipe should be properly abandoned. FIELD_STRUCT_DESC: 1 of 4: 36-inch corrugated metal pipe through levee 20.0 feet below crown. One corrugated metal cutoff wall installed by United States Army Corp of Engineers, 1955. Slide gate in 36-inch corrugated metal riser on the waterward slope. Pump on the waterward bank. Concrete standpipe at toe of the landward slope (ABO No. 9374, 1974). Originally included in the 1960 O&M manual. FS Date: 3/14/2013

36-inch cmp riser on WS slope with slide gate.

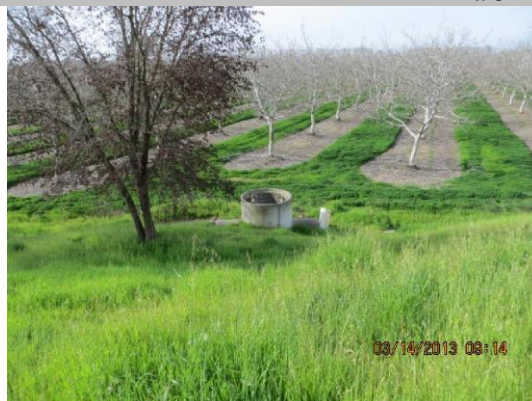
Photo 2 of 2 : UCIP_FA_2016_10261_17465.jpg

Item	DWR UCIP Field Study			38.998247 °		38.998247 °
				-121.800236 °		-121.800236 °
DWR ID						
Comment Code						
Inspector Comment						
FS_ID:10261						
DS_ID:20249						
EP_NO: 9374						
Repair Type: Non-Urgent						
Crossing Status: Found						
UCIP Comments: Appears abandoned. Pipe should be properly abandoned.						
FIELD_STRUCT_DESC: 1 of 4: 36-inch corrugated metal pipe through levee 20.0 feet below crown. One corrugated metal cutoff wall installed by United States Army Corp of Engineers, 1955. Slide gate in 36-inch corrugated metal riser on the waterward slope. Pump on the waterward bank. Concrete standpipe at toe of the landward slope (ABO No. 9374, 1974). Originally included in the 1960 O&M manual.						
FS Date: 3/14/2013

Concrete distribution riser on LS toe.
